IMPROVEMENT OF SLOPE STABILITY IN THE CAMPING FACILITIES OF “ELPIS” IN ANO POROIA OF SERRES, IN GREECE

ABSTRACT

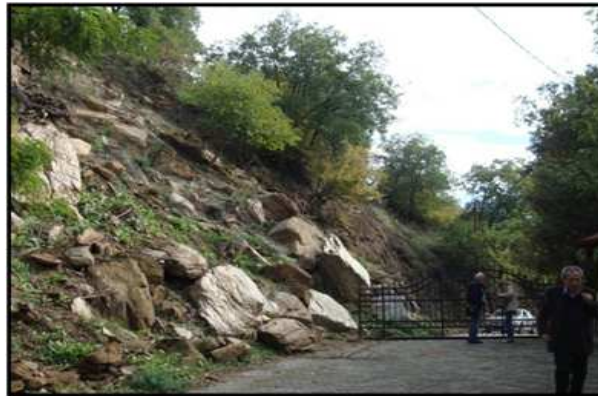
The landslide took place in June 2009, on the slope in front of the entrance to the camping facilities of the Christian Brotherhood "Elpis", in Ano Poria of Serres. The slope, which presented the failure, is 33m high, with 250°/40° orientation. The slope is located down-slope of the Church of St. George, right of the road leading to the entrance of the camp (northwesterly direction), as shown in the following elevation map (map 1). This slope is composed of mica schist, forming a part of the upper course of the crystalloschistic of Serbomacedonian, Vertiskos (Mountrakis D, 2010), combined with soil weathering material (with presence of clay material) mounted on the shale rock. The length of the maximum cross section of the landslide is 30m and the volume of landslide material was high, as illustrated in image 1, covering the access road to the camp, and then removed to improve the access.

Image 1: The Foot of the Landslide at the Entrance of the Camp. The Material of the Landslide Consists of Big Volumes of Mica Schist Combined with Soil Weathering Material

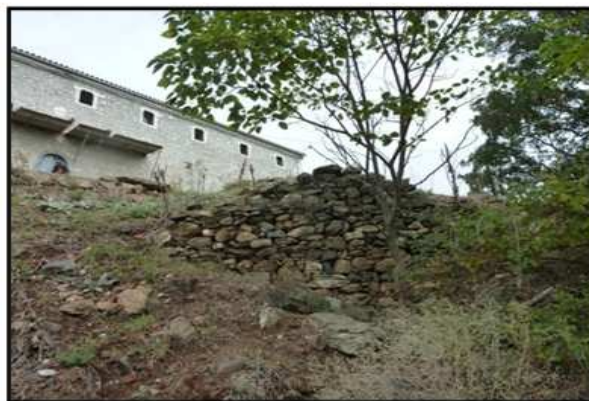
Image 2: The Church of St. George in 25m from the Upper Limit of the Landslide

the existing slope and suggest appropriate measures to deal with the landslide, so as to reduce the landslide risk in an area of particular importance, because of the existing camping facilities, 25m from the upper limit of the landslide there is the church of St. George. Furthermore, it is worth noting that downstream of the road within 25m there are private residences.

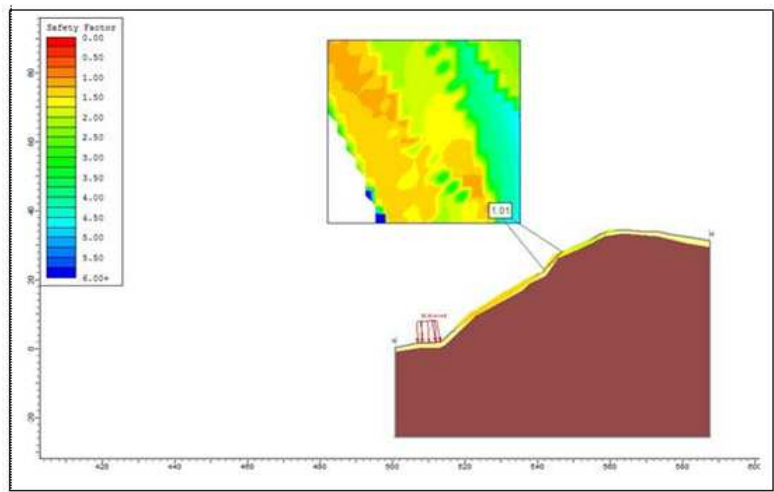
Material	Unit Weight γ (kN/m ³)	Cohesion c (kN/m ²)	φ (°)	Factor of Safety (Spencer’s method)
Soil weathering material	20	5	28	1.01

Figure 1: The Slip Surfaces with the Lowest Factor of Safety in Static-Dry Conditions (The Yellow Color Displays the soil Material Mounted on the Mica Schist-Brown Color)

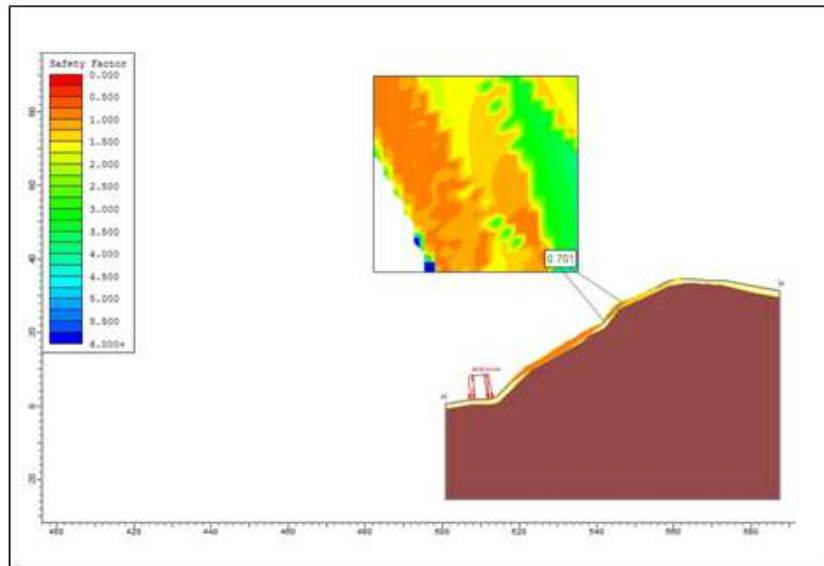
Material	Unit Weight γ (kN/m ³)	Cohesion c (kN/m ²)	ϕ (°)	Coefficient Ru	Factor of Safety (Spencer's method)
Soil weathering material	20	5	20	0.2	0.70

Figure 2: The Slip Surfaces with the Lowest Factor of Safety in Static- Wet Conditions. (The Yellow Color Displays the Soil Material Mounted on the Mica Schist-Brown Color)

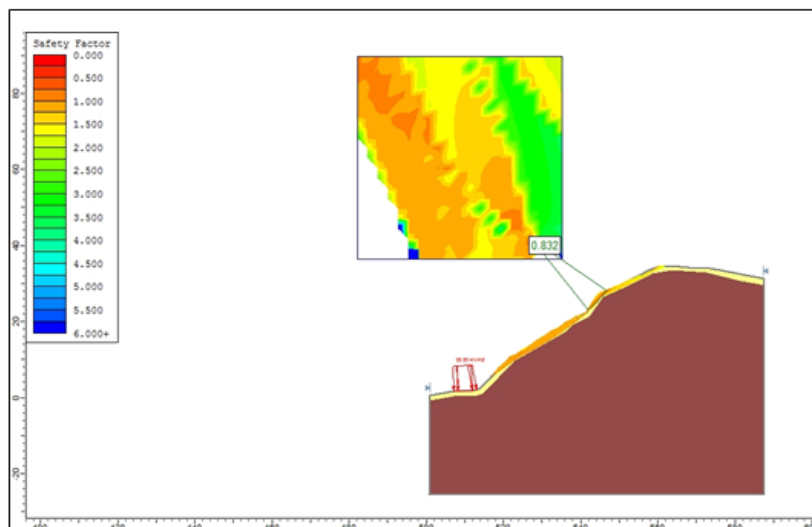
Material	Unit Weight γ (kN/m ³)	Cohesion c (kN/m ²)	ϕ (°)	Factor of Safety (Spencer's method)
Soil weathering material	20	5	28	0.83

Figure 3: The Slip Surfaces with the Lowest Factor of Safety in Dynamic- Dry Conditions. (The Yellow Color Displays the Soil Material Mounted on the Mica Schist-Brown Color)

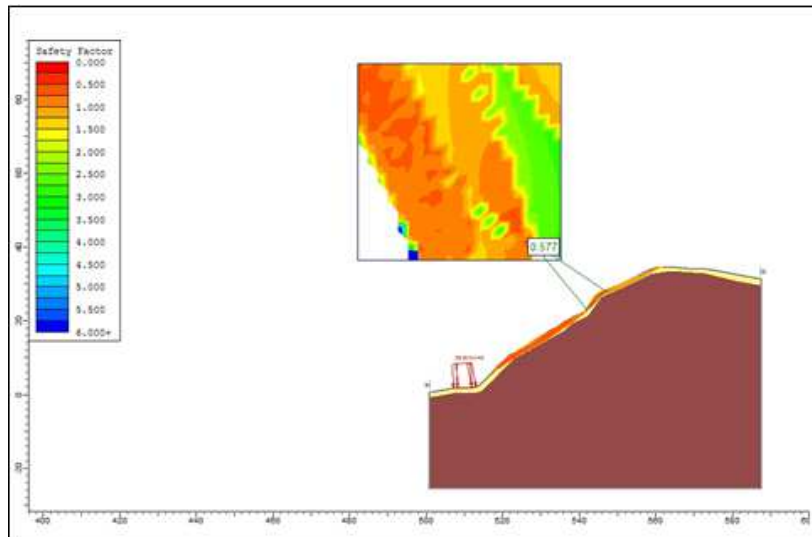
Material	Unit Weight γ (kN/m ³)	Cohesion c (kN/m ²)	ϕ (°)	Coefficient R_u	Factor of Safety (Spencer’s method)
Soil weathering material	20	5	20	0.2	0.57

Figure 4: The Slip Surfaces with the Lowest Factor of Safety in Dynamic-Wet Conditions. Yellow Color Displays the Soil Material Mounted on the Mica Schist-Brown Color

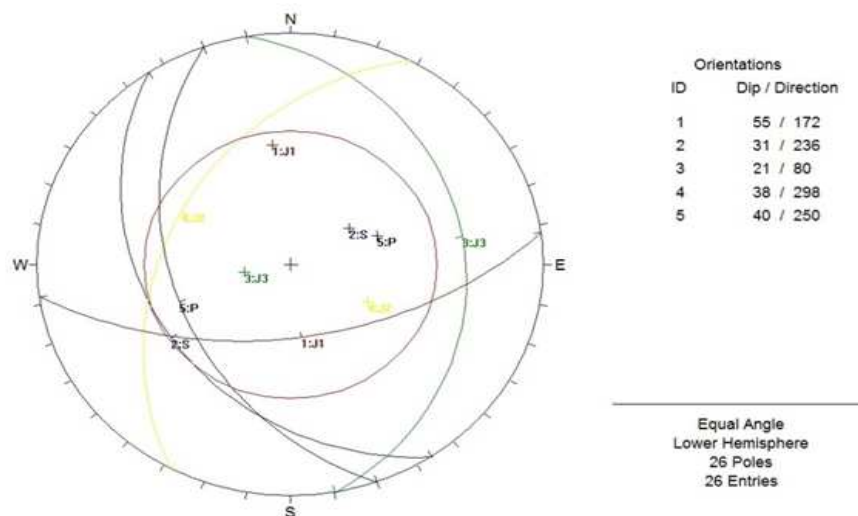
On either side of the landslide, were taken measurements with a geological compass, in order to determine the orientation of the discontinuities of the mica schist. After the elaboration of these measurements by plotting the discontinuities on the program Dips, were observed possible failures (Dimopoulos G, 2008). This limit equilibrium can easily be disrupted after an intense and prolonged rainfall, or an earthquake activity. The failures that can be occurred are: plane failure relative to the schistosity and wedge failure relative to the pair of discontinuities of schistosity and J1 (figure 5). The discontinuities in whole are opening 1-3mm, filled with clay material, which prevents the drainage of water, thereby reducing the shear strength, having an impact on the stability of the slope (Chararas V, 2005, Tsotsos S, 1991,).

Figure 5: Chart with the Projection of the Orientation of Discontinuities in Mica Schist

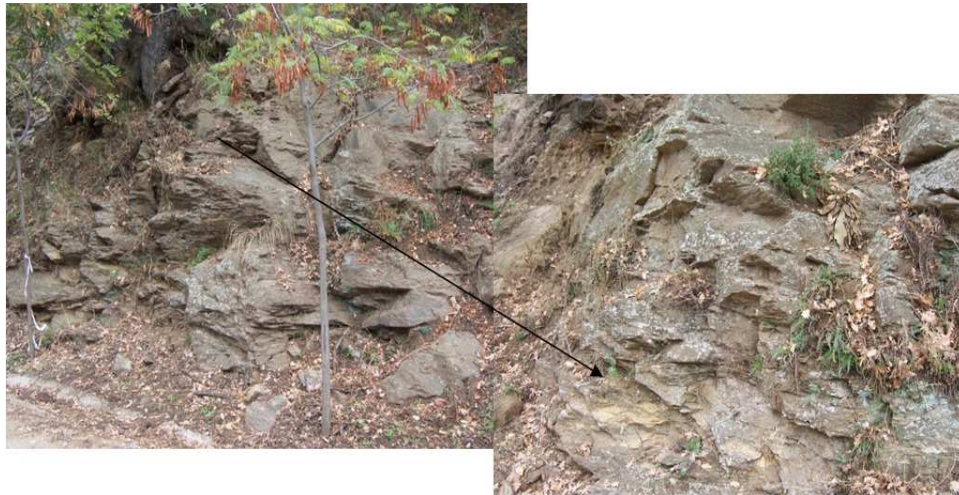
Image 3: The Mica Schists Right from the Eastern Boundary of the Landslide (in Detail the Discontinuities)
