THE IMPACT OF LOW EFFICIENT EVACUATION PLAN DURING COSTA CONCORDIA ACCIDENT

MOHAMED NABIL ELNABAWYBAHRIZ & MOHAMED HUSSEIN NASSAR HASSAN

Arab Academy for Science, Technology & Maritime Transport, Egypt

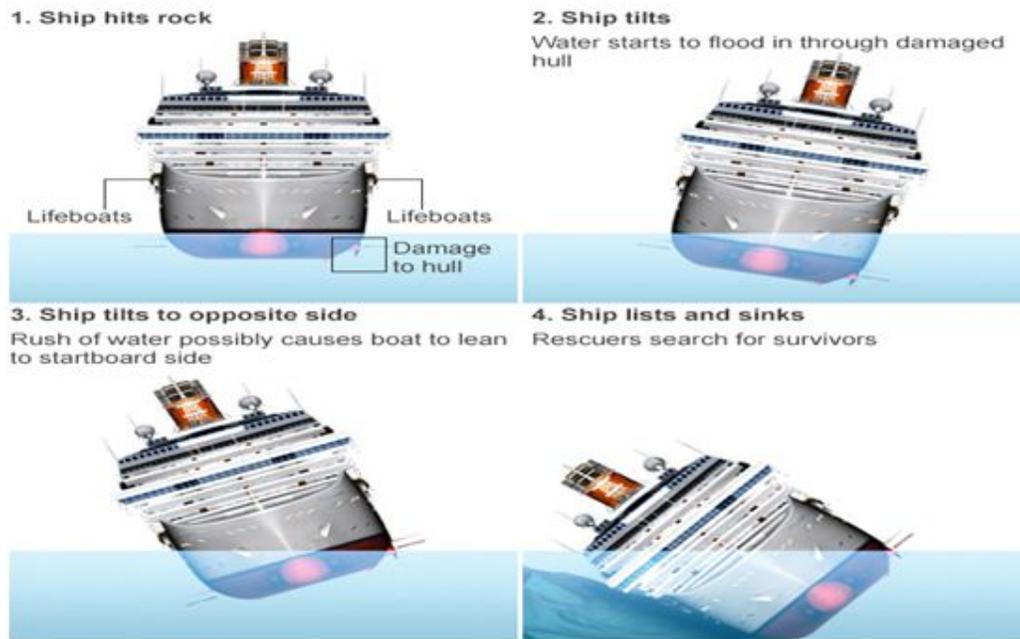
Figure 1

The ship was sailing too close to the coastline in a poorly lit shore area. The Master planned to pass at an unsafe distance at night time and at high speed (15.5 knots). The danger was considered so late that the attempt to avoid the grounding was useless. Everyone on board realized that something very serious was happening, because the ship violently heeled over and the speed immediately decreased. (MIT, 2012)

The vessel lost propulsion right away and was consequently affected by a black-out. The Emergency Generator Power switched on as expected, but was not able to provide the utilities to handle the emergency and on the other hand worked in an intermittent way. The rudder remained blocked completely starboard and no longer handled. The ship turned starboard by herself and finally grounded (due to favorable wind and current) at the Giglio Island at around 23.00 and was seriously heeled (approximately 15°). (MIT, 2012)

From the analysis carried out under the direct coordination of the Master, the seriousness of the scenario was reported after 16 minutes. After about 40 minutes (22: 27) the water reached the bulkhead deck in the aft area. (MIT, 2012)

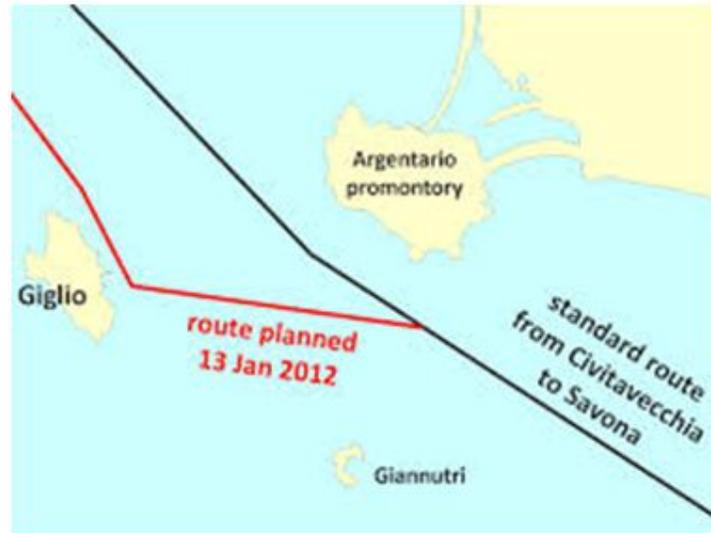
Figure 2

Approaching the shore, she collided with the "Scole Rocks" below the waterline on her port side, which led to the damage of 5 watertight compartments (WTCs). In addition, the electric propulsion motors, all diesel generators as well as the main switchboard were damaged. The initial list was to port due to the leak being on that side and because of the heeling moment caused by the rock, which stuck amidships after the impact. After a while, the flooding became almost proportional and the ship went upright again. (MIT, 2012).

Having been damaged in compartments vital for power generation, power distribution and propulsion, the ship was soon adrift without electricity. Even though the emergency diesel generator started up, it did not work reliable enough to provide power. Therefore, emergency power was supplied by UPS (Uninterruptible Power Supply) batteries. However, the steering gear did not function and thrusters needed more than the emergency power provided. Due to wind and current, the vessel was ultimately moved north of Giglio harbor before the forces of nature turned her around 180 degrees and pushed her in the direction of the island until she grounded a second time. (OMAE, 2014)
