## BRITTLE FRACTURE OF GRP ROD USED IN POLYMERIC INSULATORS AN EXPERIMENTAL STUDY

*In this paper, a detailed study has been carried out on the failure of Glass reinforced polymers (GRP) used in composite insulators. Different GRP rods were tested in inclined plane test and a portion of the sample of GRP rods were tested to obtain brittle fracture in the laboratory. The severity of HNO<sub>3</sub> solution used in the tests were 0.1N and 0.5N. Two different electrode materials of copper and stainless were used in the experiment. After obtaining the erosion of the material, the rod was subjected to mechanical tensile load test. A sample rod has yielded prior to specified mechanical load.*

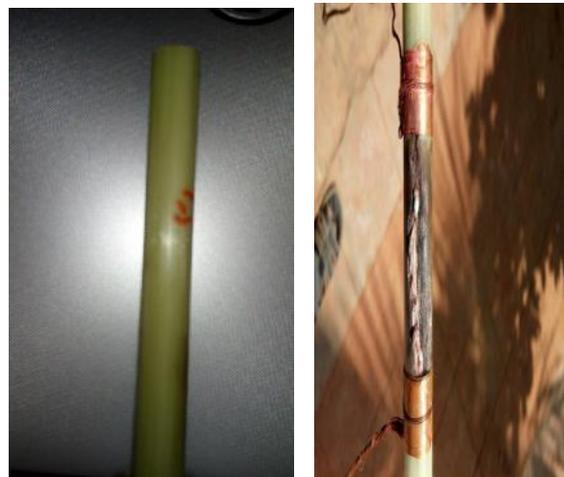
**Figure 4: FRP Rods Before and After the Tests**

**After Testing at 1.6kV**

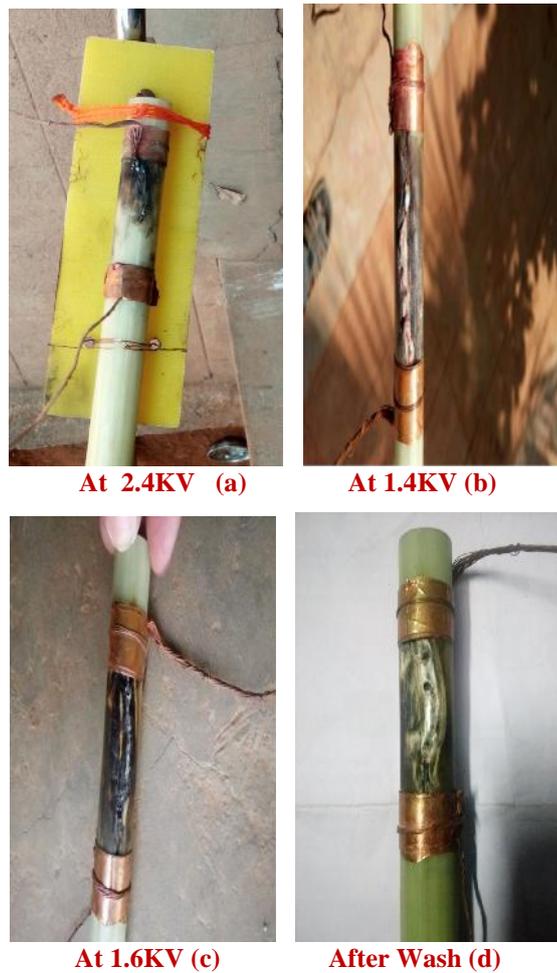
**Figure 5: GRP Rods after Tests**

When copper foils were used as electrodes, it was found during an experiment, that copper was forming cupric sulphate on the surface of GRP rod. This formation was leading to permanent surface conduction on the GRP rod. Hence, it was thought that it can be avoided in subsequent experimentations. The second setup of the experiment was initiated using stainless steel foils, in which there was no formation of conductive paths on the surface. Further tests were conducted using stainless steel foils as electrodes and there was no conductive path between the electrodes.

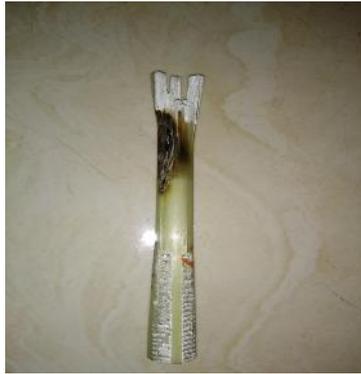
**Figure 6: Brittle Fracture**

Since the mechanical load was not applied during the above tests, GRP rod was subjected to tensile strength test. The GRP rod got fractured at peak load of 68KN. The photograph of brittle fracture is as shown in Figure 4. It can be seen from the results that the GRP rod is of very good quality.
