## ANALYSIS OF THE STABILITY VARIATION OF A SLOPE CROSSED BY FOREST FIRE

ROMINA SECCI, SERGIO V. CALCINA, GAETANO RANIERI & GABRIELE URAS

Department of Civil Engineering, University of Cagliari, Environmental Engineering and  
Architecture DICAAR, Cagliari, Italy

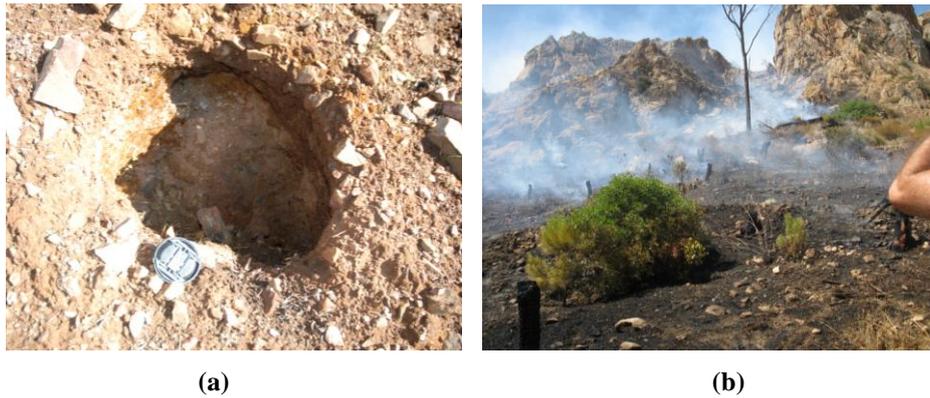
Figure 1: (a) Rut Caused by the Uprooting of Trees after the Fire; (b) Fire of August 2012

This is detectable in situ and through the analysis of historical orthoimages. The first surveys carried out in 2011 and 2012, in the month of September after the forest fire, put in evidence widespread shallow erosion forms, especially where vegetation had been the eradicated (Figure 1a). The upper top soil layer, 20-50 cm thick, mainly consisted of ash, resulting from vegetation combustion. The last event dating back to August 2012 is classified from high to moderate soil burn severity [24] and has produced extensive damages to the cover vegetation (Figure 1b).

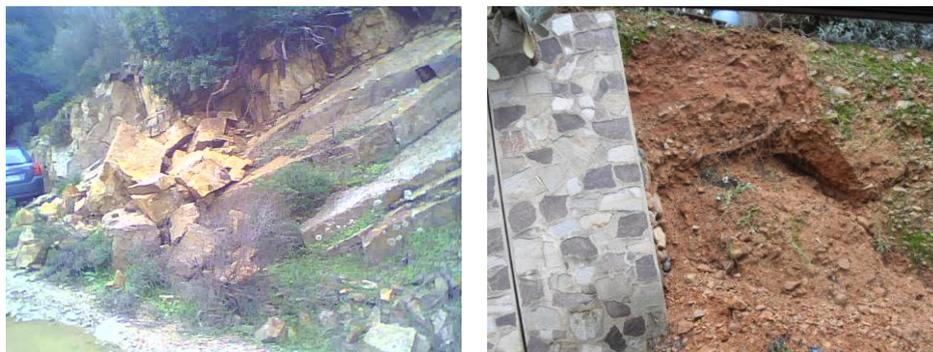
Figure 2: Some Images of Collapses and Shallow Slope Instability Phenomena Occurred after the Rains (November 2012)

The reduced stabilization effect of the vegetation and subsequent heavy rains have encouraged instability phenomena of shallow layers along the slopes. Figure 2 shows some collapse phenomena in correspondence of several road segments. Before the fire crossing the topsoil was low plastic (with plasticity index ranging from 5 to 10) in both upstream and downstream parts of the slope.

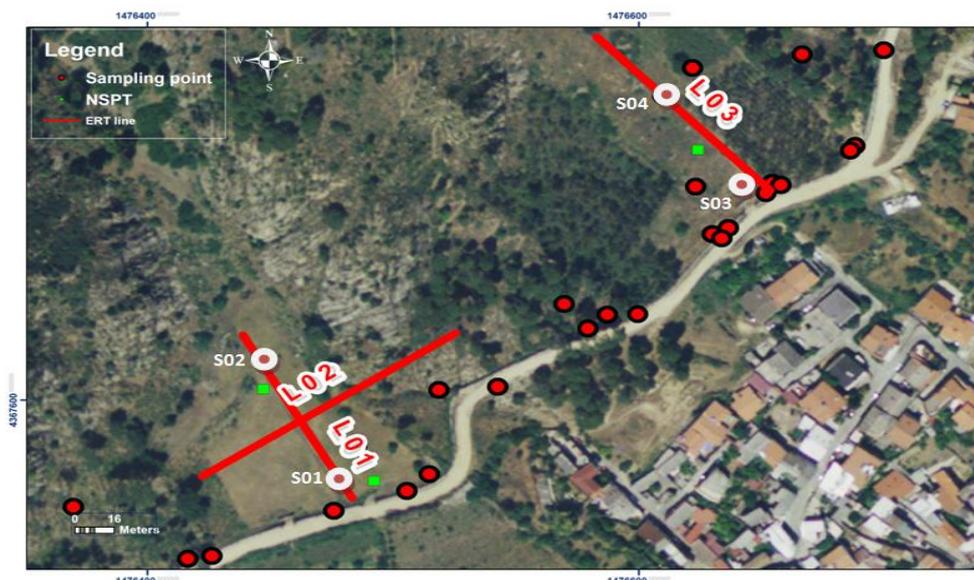
Figure 3: Map of the Study Area with the Locations of the ERT Profiles, the NSPT Measurements and the Soil Sampling Points in Monte Omo Slope

Geophysical and geotechnical surveying methods are employed to outline the geological features and mechanical parameters necessary to define the geotechnical models of the site. In particular, the electrical resistivity tomography was used to evaluate shallow layer thickness and define bedrock morphology, and the results of non-standard penetration tests and non-invasive surveys were compared. The soil mechanical parameters were obtained by direct shear laboratory tests performed on several soil samples collected in the study area, as shown in Figure 3.

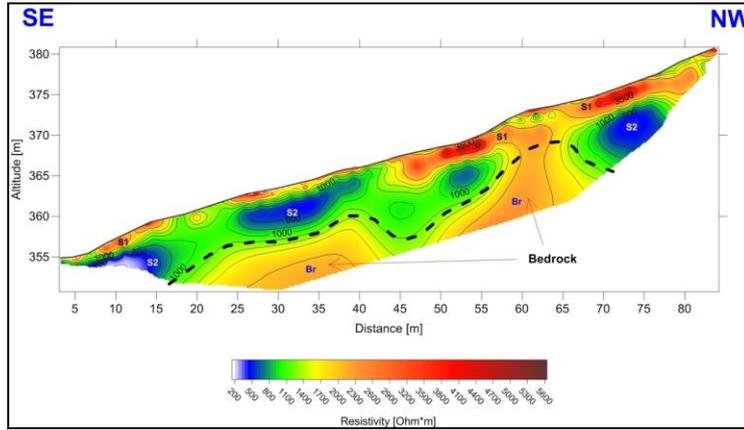
**Figure 4: 2D Electrical Resistivity Tomography with Residual RMS Error of 2.4 % Generated from Extended Survey Line L01 (Wenner-Schlumberger Array)**

The black dashed line plotted in Figure 3 denotes the supposed interface with the intact granitic bedrock. A clear deepening of bedrock can be observed in the central part of the electrical profile. The 2D model along the L02 line, crossing the L01 line at the electrode 24, shows a strong resistivity lateral contrast. In accordance with the surface geological observations this resistivity anomaly is related to the structural features of the granite basement. In particular, the blue dashed line, plotted in Figure 5, is interpreted as a normal fault. Also in this model there is the same uppermost resistive layer correlated with coarse and dry materials with thickness ranging from 0.5 to 2 meters. Whereas the L03 model plotted in Figure 6 shows a more complicated resistivity distribution. In particular, there is the same shallow

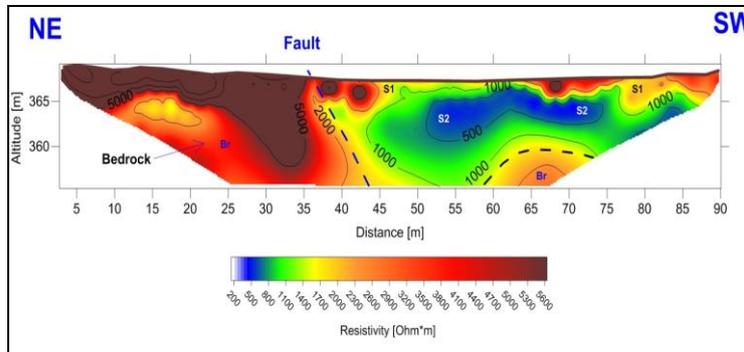
**Figure 5: 2D Electrical Resistivity Model with Residual RMS Error of 3.0 %, Generated from Line L02 (Wenner-Schlumberger Array)**

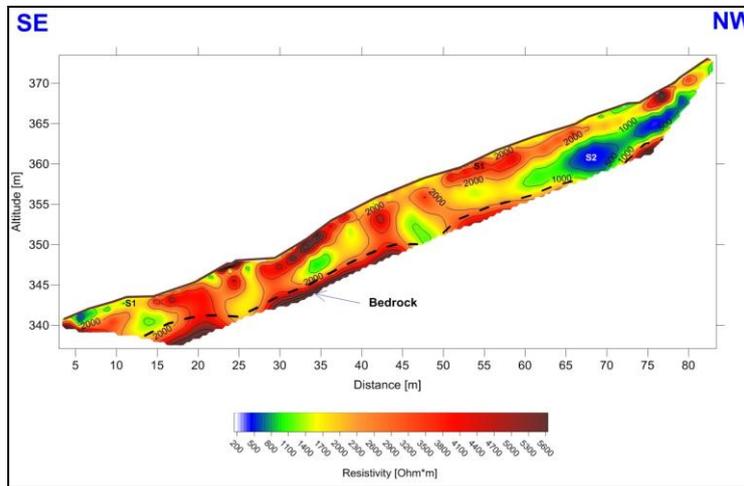
**Figure 6: 2D Electrical Resistivity Model with Residual RMS Error of 5.6 % for the Line L03 (Dipole-Dipole Array)**

high-resistive layer with variable thickness of 2-3 meters but the second layer is more resistive than the previous cases with minimum resistivity values at the higher altitude (around 500  $\Omega\text{m}$ ). At depths between 4 and 8 meters the resistivity values exceed 2,000-3,000  $\Omega\text{m}$ , in agreement with bedrock presence.

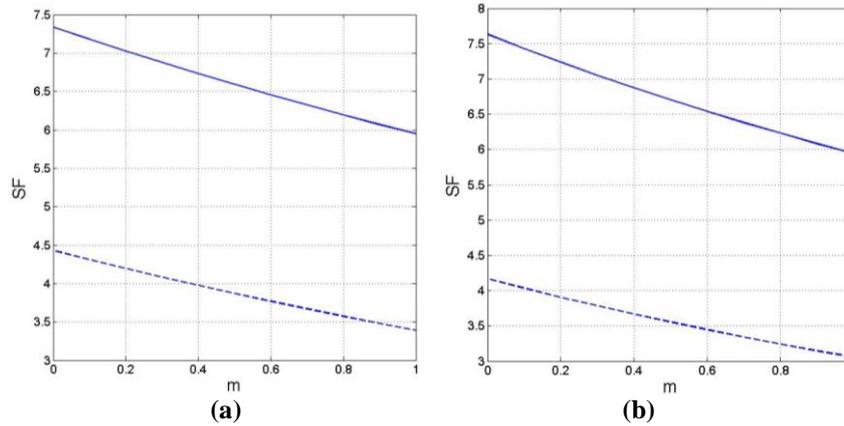
**Figure 7: Examples of the Safety Factor for the Same Slope Gradient as Function of m Parameter before (Solid Line) and after (Dashed Line) the Fire Passage for L01 Profile (a) and for L03 Profile (b)**

However, the comparison between the SF values, derived before and after the wildfire, shows a significant reduction between the two different conditions. An example of safety factor calculated with the above equation is shown in Figure 7, where it is possible to observe the difference between the solid function, which denotes the SF before the wildfire for several  $m$  values and the dashed function, which indicates the SF computed by using the shear strength parameters of the burned soil.

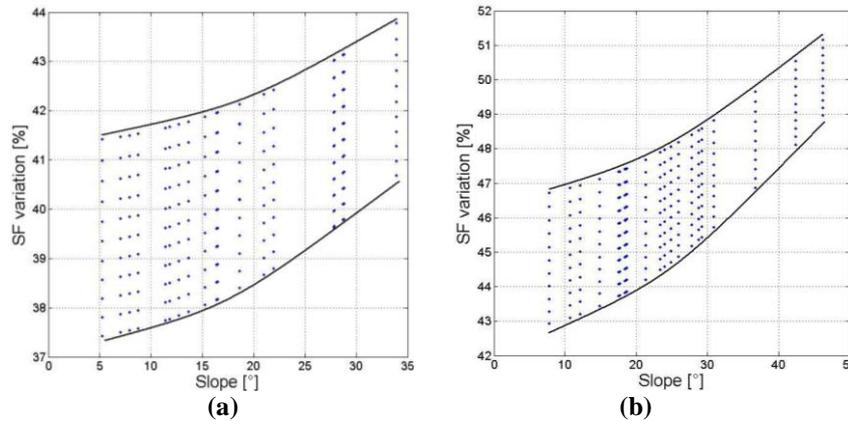
**Figure 8: Percentage Reduction of the Safety Factor SF for Different Slope Angles between m=0 (Dry Soil) and m=1 (Saturated Soil) Considering a Parallel Seepage to the Sliding Surface, Respectively for L01 Profile (a) and for L03 Profile (b)**

Figure 8 shows the trend of the percentage relative variation of the stability factor in relationship to the slope inclination. The variation percentage, calculated according to the following expression:

highlights that the reduction of the stability coefficient ranges between 37.5 and 44 % for the profile L01 and from 42.5 to 51.5 % for the profile L03. Furthermore, this trend increases with the gradient of slope.
