## COMPARATIVE SURFACE DAMAGE DETERMINATION AT A JEWISH GRAVE USING TWO DIFFERENT MOBILE ULTRASONIC VELOCITY DEVICES

**KEYWORDS:** Depth of Cracks, Historical Monument, Non-Destructive Methods, Surface Weathering Degree, Ultrasonic Velocities

### THE MONUMENT INVESTIGATED

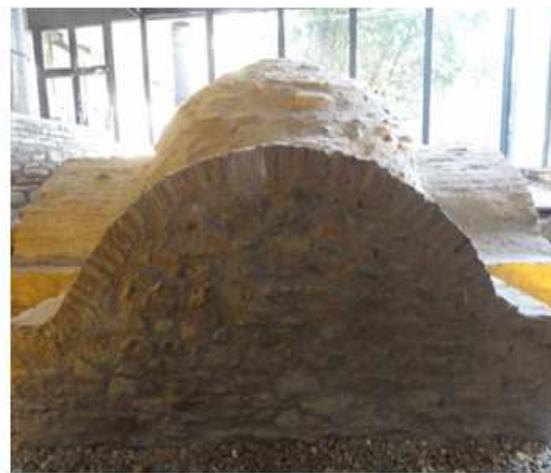
Figure 1: A general Option of the Monument

This tomb dates in the first quarter of 4<sup>th</sup> century and belongs to a member of Israelite community in Thessaloniki and was founded in university campus between the central administration building and the building of Law and Economic Sciences. It is about a well-preserved historical monument with favorable position for taking the ultrasonic measurements, (Marki E., 2001).

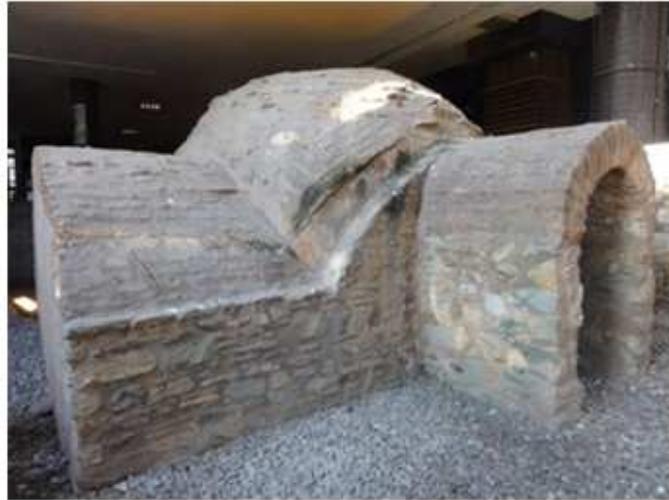
**Figure 2: The Entrance of the Monument**

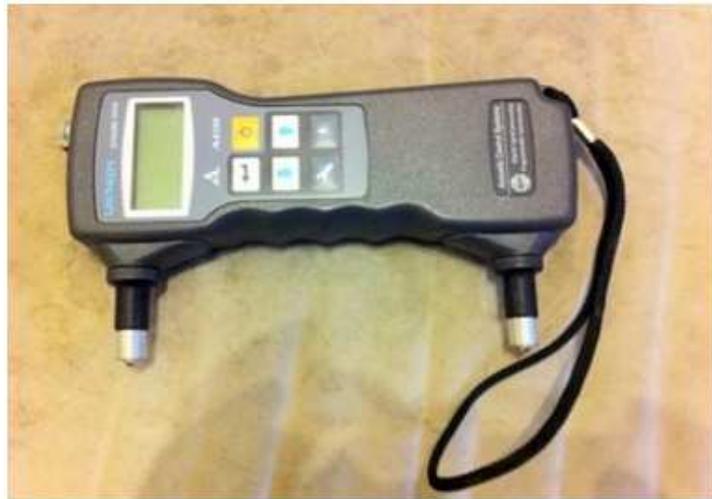
Figure 3: The Surfer Ultrasonic Detector

For evaluating the weathering degree of the monument surfaces were used two ultrasonic devices, the SURFER ultrasonic detector (Figure 3) and the PUNDIT ultrasonic non-destructive digital tester (Figure 4), (Bruneau, C., Forrer, A. & Cuche A., 1995). The SURFER detector is applicable for measurement of ultrasound velocity and time of longitudinal ultrasound wave's propagation in solid materials at surface sounding testing method for estimating the quality of the materials. This estimation is based on the correlation of ultrasound wave's velocity in material to its physic and mechanical characteristics and physical statement. The SURFER gives the chance of estimating the depth of the crack (mm) on the surface by calculating the time of ultrasonic wave's propagation. This device maintains a stable distance between the two ultrasonic probes (15cm) which gives the ability of mapping and allocating the weathering of specific surfaces. On the other hand, the PUNDIT ultrasonic non-destructive digital tester is a good index characteristic for determining the physic-mechanical behavior and evaluating the weathering degree of the rocks. For the measurements a pair of small edge transducers was used for estimating the P-wave velocity for the determination of the depth. The tests held out by using the indirect method referring to arrangement of the transducers (transmitter and receiver) on the same surface of the stone. The transmitter was stable along a calibrated line and the receiver was reinstalling at every 5cm. The final result was the travel time in correlation with the distance in each place. Each pair (travel time-distance) is displayed on a diagram. Given the fact that the most weathered surface demands longer travel time propagation, the change of slope in the plot indicates the quality of the material

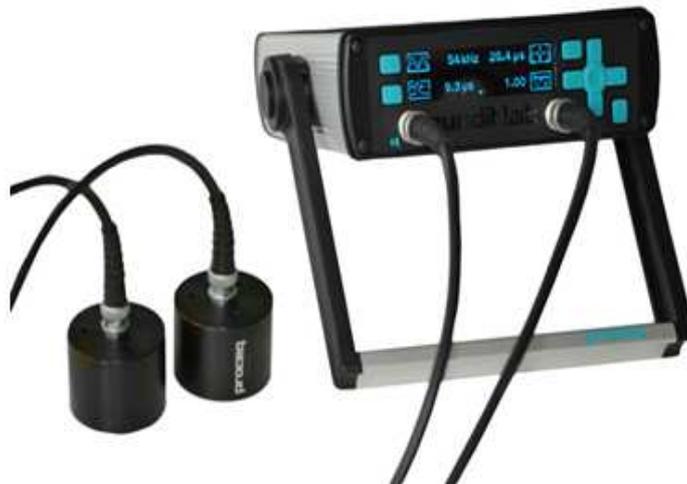
Figure 4: The Pundit Ultrasonic Device

Except for the SURFER device, PUNDIT Ultrasonic non-destructive digital tester also was used for determining the physic and mechanical characteristics and evaluating the weathering depth. For the purposes of the measurements, the indirect method was used. The final result was the travel time in correlation with the distance in each place. As it is known, the most weathered surface needs longer travel time propagation, so the change of slope in the plot indicates the quality of the material.

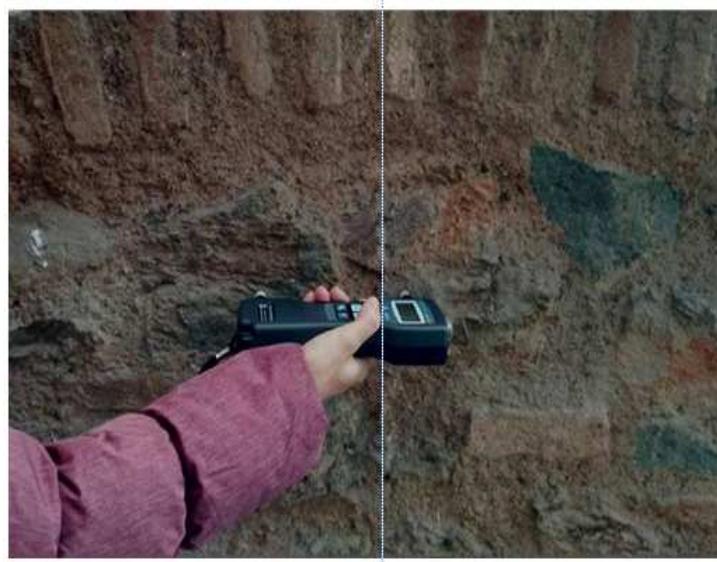
**Figure 5: The use of Surfer Device on the Monument**

First of all, the SURFER device was used for mapping 4 specific surfaces of the monument (the back surface, the convex one upon the back surface, the dome and the entrance of the tomb), by taking a big amount of measurements, approximately 459, (Figure 5).

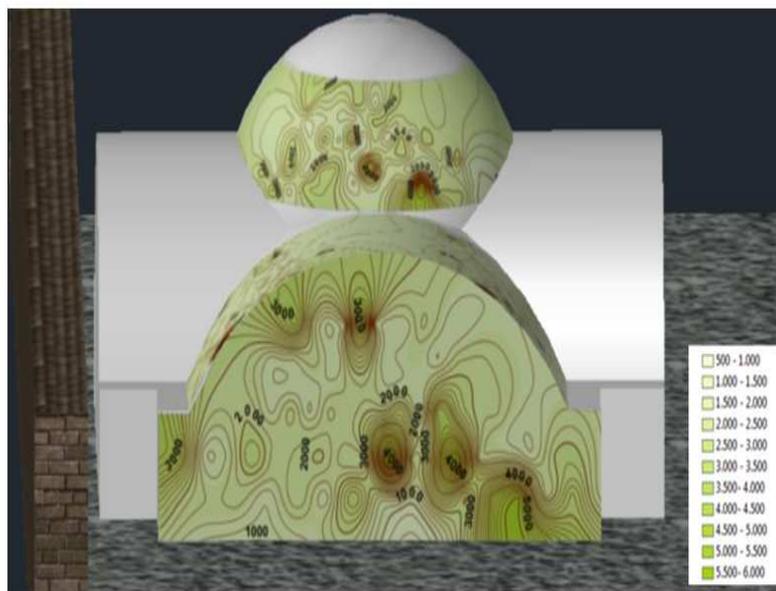
The application of this method was implemented for the allocation of the weathering along these surfaces, by the construction of 4 maps. Each map depicts the ultrasonic velocities  $V_p$  (m/sec) and the way they are distributed depending on the weathering conditions of each surface. The most weathered parts take lower values (longer travel time propagation), so in Figure 6 (back surface), it is obvious that the biggest part (in the right part and left half part of the tomb) is displayed with the lightest colors, assigning the most weathered areas, with  $V_p= 1200-2000$  m/sec in the first most weathered part and  $V_p= 800-2000$  m/sec in the second most weathered part of the back surface.

**Figure 6: The Back Surface of the Monument (The Maps Were Made with ARC GIS 2010 and the Depiction of the Maps was Made Upon the Model, by the Use of the AUTOCAD 2012. The Legend is the same for all the Maps, Showing the Ultrasound Velocities  $V_p$  (m/sec))**

According to the Eq. (1) was estimated the depth of each weathered zone of the surfaces of the monument. In detail, the back surface was devised in two areas: in the first area the depth was calculated in  $D=66$  mm, while in the second one was  $D=92.4$  mm. At the same way, the depth of the weathering at the convex part upon the back surface is about  $D=83$  mm and at the dome as it is shown in the following plot (Figure 11), the travel time of P- waves is constant in depth higher than  $D= 35$ mm. Furthermore, the entrance of the tomb consists of the right side with weathering depth  $D=79$  mm and the left one with the same weathering depth.

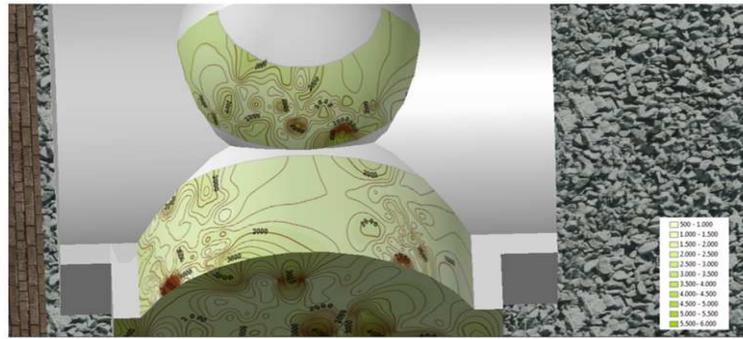
At the same way, along the convex part, upon the back surface appears clearly the weathered part, the values of which range in lower levels than those in the back surface, with  $V_p=500-2000$  m/sec (Figure 7).

**Figure 7: The Convex Part upon the Back Surface, (the Maps were Made with ARC GIS 2010 and the Depiction of the Maps was Made upon the Model, by the Use of the AUTOCAD 2012) the Legend is the same for all the Maps Showing, the Ultrasound Velocities  $V_p$  (m/sec)**

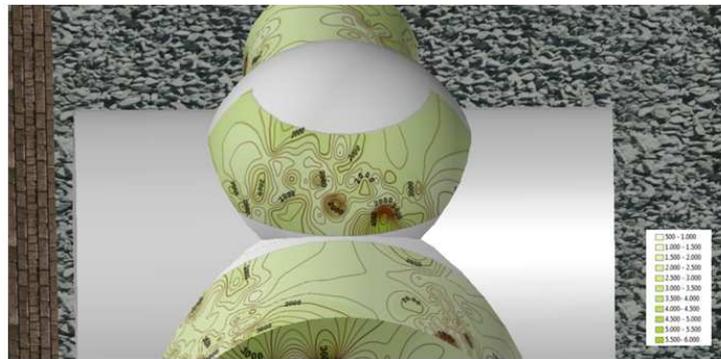
In figure 8, the dome of the monument appears to have a wide weathered area which ranges between 1000- 2000 m/sec

**Figure 8: The dome of the Monument, (The Maps were Made with ARC GIS 2010 and the Depiction of the Maps was Made Upon the Model, by the Use of the AUTOCAD 2012). The Legend is the same for all the Maps Showing, the Ultrasound Velocities  $V_p$  (m/sec)**

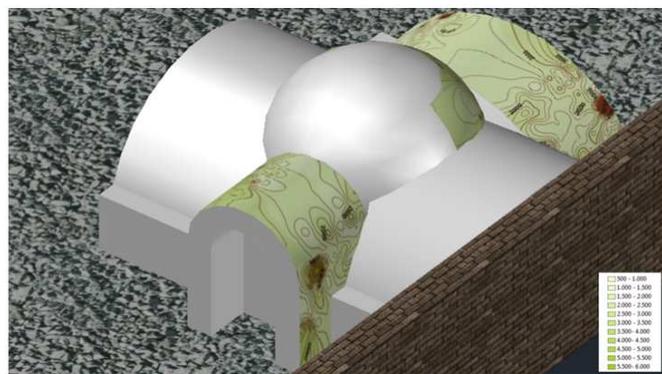
Finally, at the entrance of the tomb, there are distinguished 2 weathered areas that appear to have the same values both in the right and in the left semicircular part. The values of the velocity range at a width of 1800-2000 m/sec, (Figure 9 and 10).

**Figure 9: The Right Part of the Entrance, (the Maps were Made with ARC GIS 2010 and the Depiction of the Maps was Made Upon the Model, by the use of the AUTOCAD 2012). The Legend is the same for all the Maps Showing, the Ultrasound Velocities  $V_p$  (m/sec).**

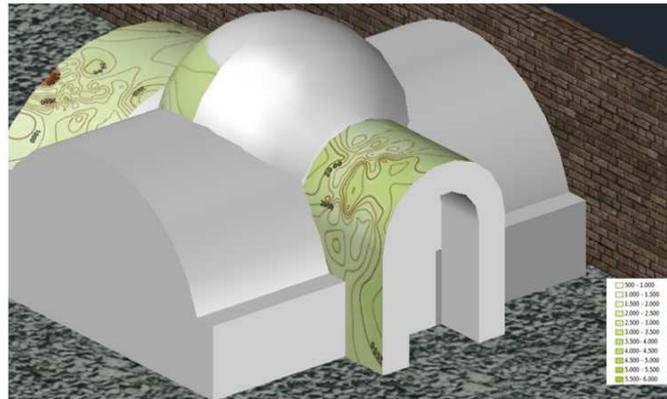
**Figure 10: The Left Part of the Entrance, (the Maps were Made with ARC GIS 2010 and the Depiction of the Maps was Made Upon the Model, by the use of the AUTOCAD 2012). The Legend is the same for all the Maps Showing, the Ultrasound Velocities  $V_p$  (m/sec)**

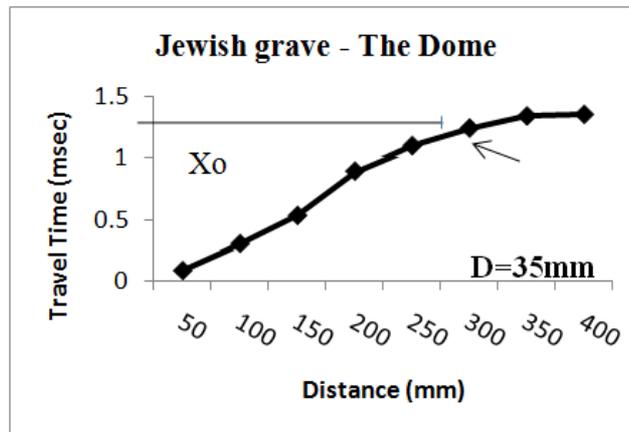
**Figure 11: Estimation of the Weathering Depth on the Surface of the Dome in the Jewish Grave**

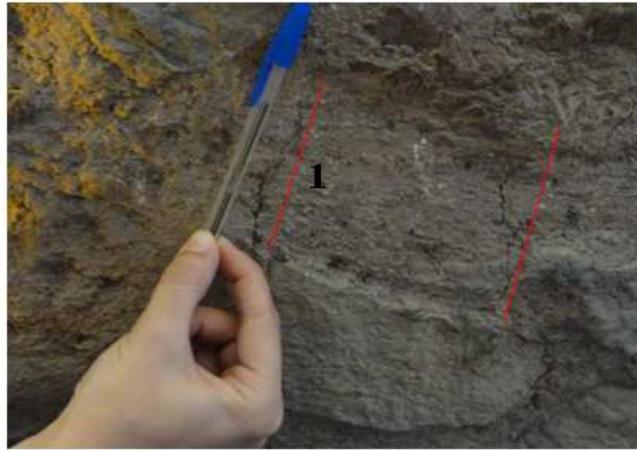
As it was mentioned before, the SURFER device gives the opportunity of determining the depth of the cracks of the surfaces. On the back surface of the monument are distinguished two cracks (Figure 12), the depths of which were measured as follows: for the first crack the depth is  $D=88$  mm, while for the second one is  $D=45$  mm.

**Figure 12: The Two Cracks on the Back Surface**

First of all, held out the mapping of specific surfaces on the monument by allocating the ultrasonic velocities ( $V_p$  m/sec), using the SURFER device detector. It is observed a wide range of values of the velocities between 500 and 6000 m/sec depending on the case. On the other hand, the depth of the weathered zones of the tomb was estimated by using the PUNDIT ultrasonic non-destructive digital tester. The weathering depth has a minimum value,  $D=35$  mm and a maximum one,  $D=92$ , 4 mm with corresponding minimum velocities 800-1000 m/sec. Finally, two cracks were located and measured on the back surface of the monument, with the SURFER device and the depth of which was determined in  $D=88$  mm and  $D=45$  mm.
