## BRITTLE FRACTURE OF GRP ROD USED IN POLYMERIC INSULATORS AN EXPERIMENTAL STUDY

*In this paper, a detailed study has been carried out on the failure of Glass reinforced polymers (GRP) used in composite insulators. Different GRP rods were tested in inclined plane test and a portion of the sample of GRP rods were tested to obtain brittle fracture in the laboratory. The severity of HNO<sub>3</sub> solution used in the tests were 0.1N and 0.5N. Two different electrode materials of copper and stainless were used in the experiment. After obtaining the erosion of the material, the rod was subjected to mechanical tensile load test. A sample rod has yielded prior to specified mechanical load.*

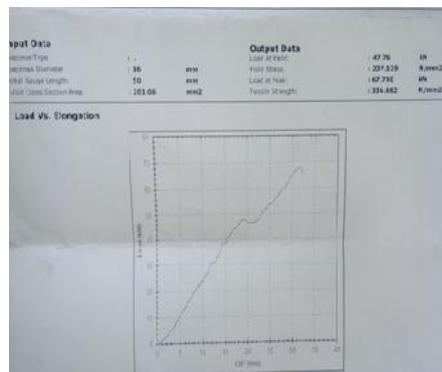
**Figure 7**

Since the mechanical load was not applied during the above tests, GRP rod was subjected to tensile strength test. The GRP rod got fractured at peak load of 68KN. The photograph of brittle fracture is as shown in Figure 4. It can be seen from the results that the GRP rod is of very good quality.
