IS THERE AN EASY SOLUTION TO MOORING ACCIDENTS

ABSTRACT

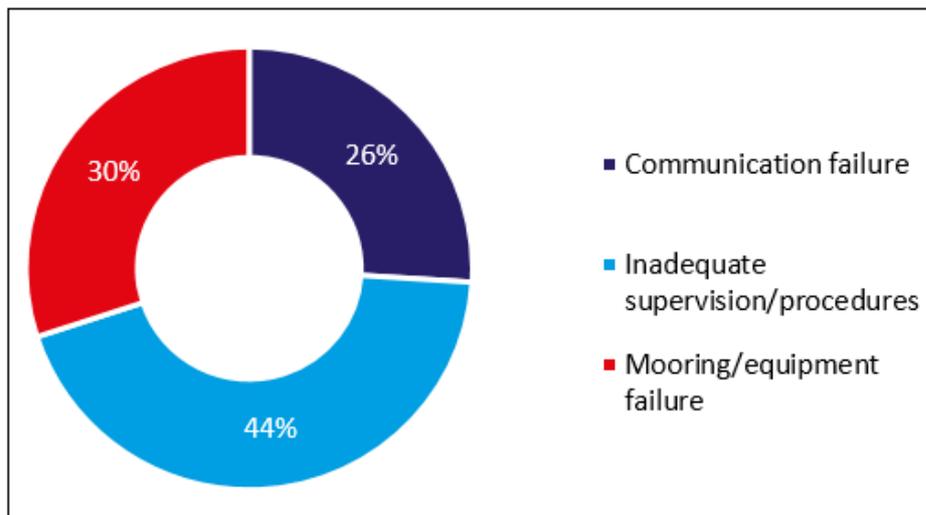
Figure 1: Distribution of Causation Analysis Claims in 2016.

The Ship owners Club issued the latest in a series of risk assessment articles emphasizing on risk assessments from mooring and unmooring operations. In 2016, the Club has experienced a high volume of claims which arose from three main areas of causation [5]. Figure 1 demonstrate those areas as following:

- Inadequate supervision/procedures, 44% of total claims, these include claims arising from a lack of supervision of the task, inadequate or non-existent procedures or a failure to comply with existing procedures.
- Mooring/equipment failure, 30% of total claims, these include claims which involved a failure of mooring equipment, mooring ropes and anchors used for mooring.
- Communication failure, 26% of total claims, these include claims arising from communication failures between the various teams involved in mooring operations such as, the bridge team, the pilot and the deck mooring team as well as the tugs/ shore mooring personnel.

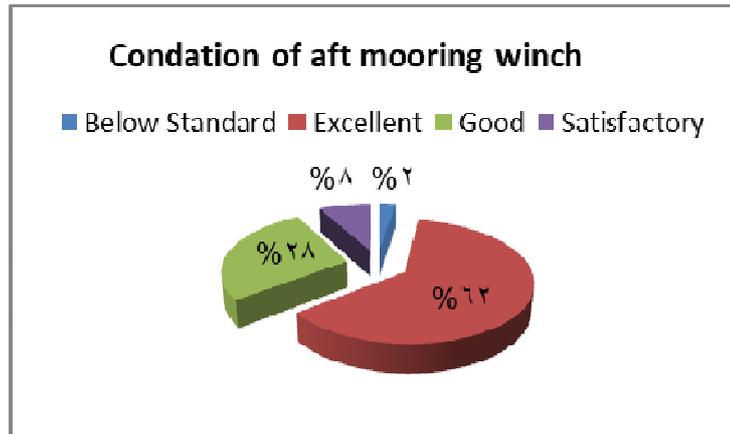
Figure 2: Questionnaire Regarding of Aft Mooring Winch.

Some of senior officers through the interview noted that, despite the overall good condition of the mooring winches, it was sometimes difficult to grease the equipment correctly. It is important that all greasing points are free, working correctly and have not been painted over. 48 % of the participants of the questionnaire carried out brake tests annually, 36% did not and 16% it was not applicable. Figure 4 explains the percentage of questionnaire regarding ship’s keeping mooring on drum ends.

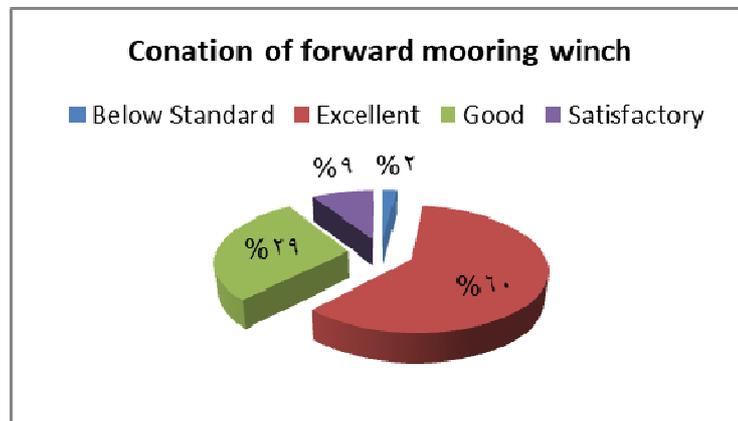
Figure 3: Questionnaire Regarding Condition of Forward Mooring Winch.

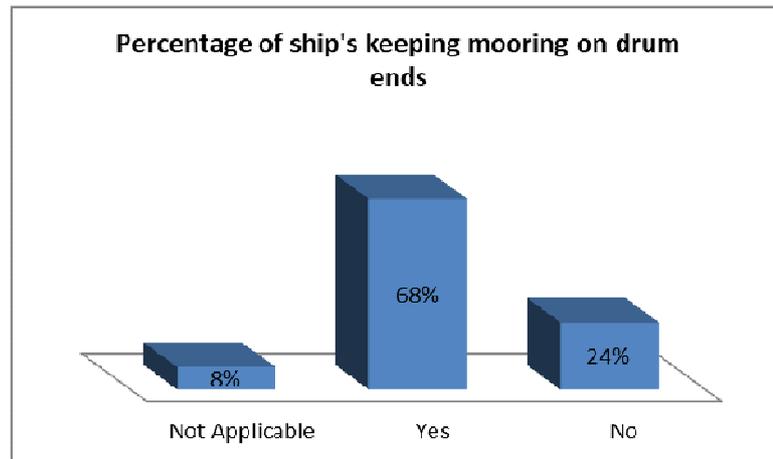
Figure 4: Statistics of Mooring on Drum Ends.

The Figure show that about 68% of the participants noted that last ship of their joining, vessels kept moorings on the drum ends instead of making them fast. Most of senior officers through the interview noted most of vessels had painted the drum ends. And all ropes, wires and Tonsberg links used for mooring have a certificate.

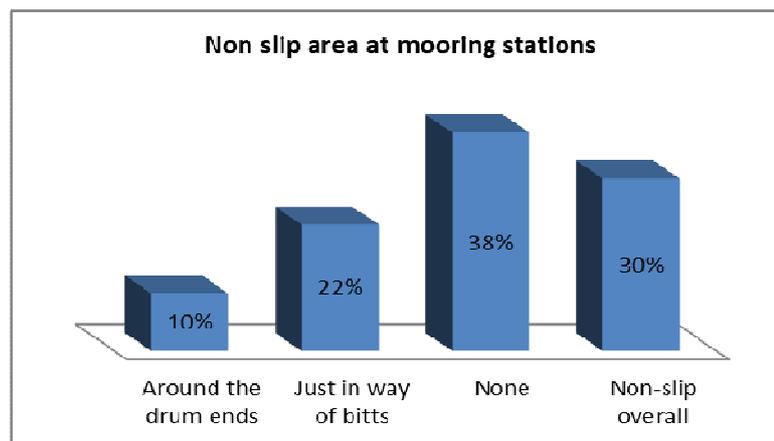
Figure 5: Questionnaire of Non-Slip Area at Mooring Stations.

With reference to the non-slip area at mooring stations; Figure 5 illustrates the types of deck area at mooring station.

Despite 30% of last ships for the participants having fully non-slip decks and 38% had none at all. It is a fact that mixing sand, or an approved non-slip aggregate, into the paint prior to application can be a very effective measure in helping to reduce mooring accidents. Through the interview most of senior officers noted that bitts, rollers and fairleads were generally in good order.

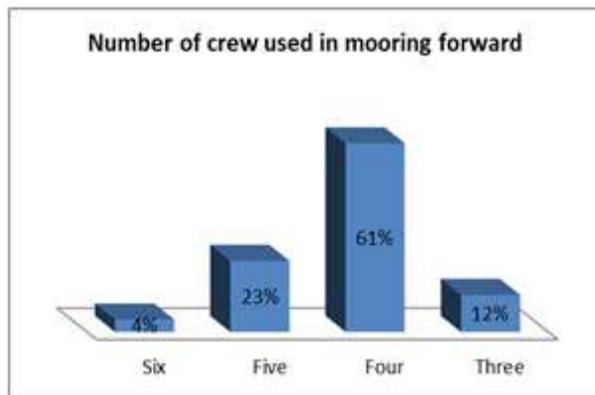
Figure 6: Number of Crew in Mooring Forward

It is important to have sufficient personnel to be able to moor the vessel safely and effectively. Figure 6 and 7 illustrate the most common number for both forward and aft was 4 crew member with numbers ranging from as low as 3 (22% aft, 12% forward) and as high as six (4% forward and aft). The third key factor raised is predominantly related to procedures and practices, the use of insufficiently trained crew is still a significant issue.

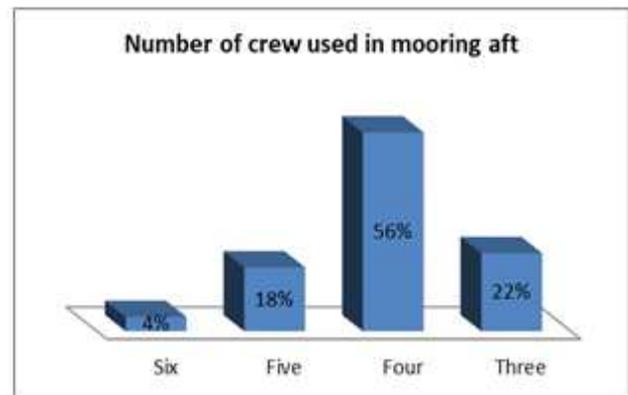
Figure 7: Number of Crew in Mooring Aft
